Minerals Inspection Report

Mine Name: Pearl Queen Mine - Pearl Queen area (SITLA)	Permit Number: M/001/0027	Mine Status: Reclaimed
Operator Name: Basin Perlite Company	Inspection Date: 7/1/2014	Permit Fees: Paid
Inspector(s): Peter Brinton	Inspection Time: evening	Bond Amount: \$57,700
Attendee(s): none	Weather: warm, sunny	Bond Escalation: N/A
Inspection Purpose: Operator requested bond release		Prior Inspection: 9/30/2010

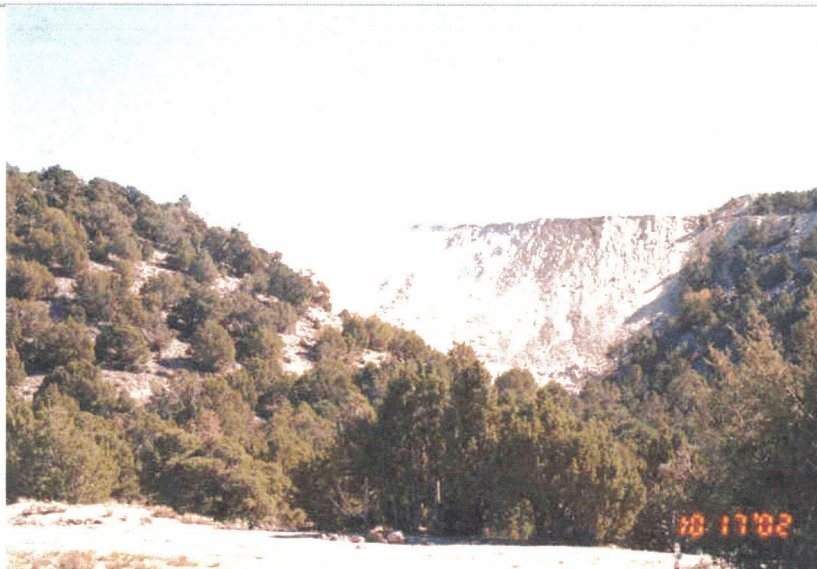
North dump in 2002. It appears that most of the dump is overburden. Note the white material on the left (west).

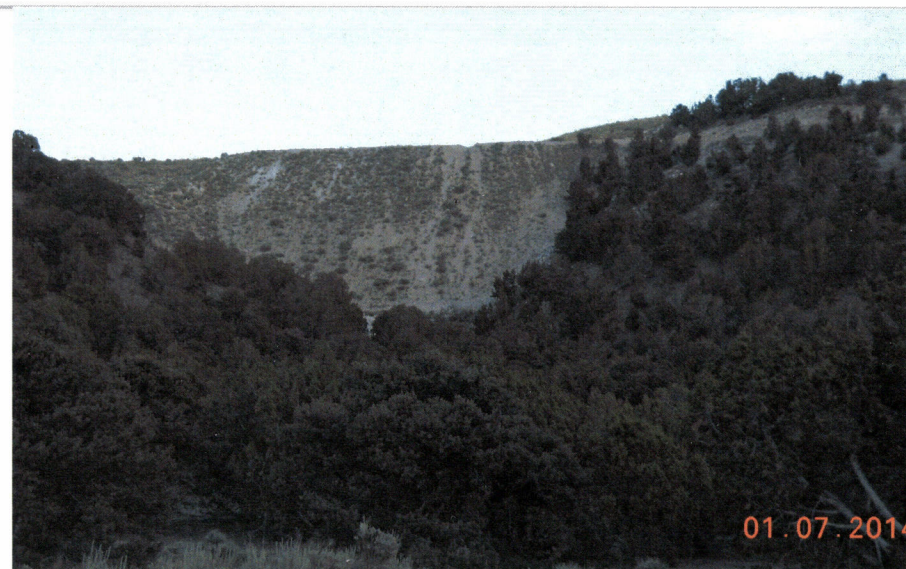
North dump in 2014. Note the vegetation and scattered but relatively minor erosion and rilling.

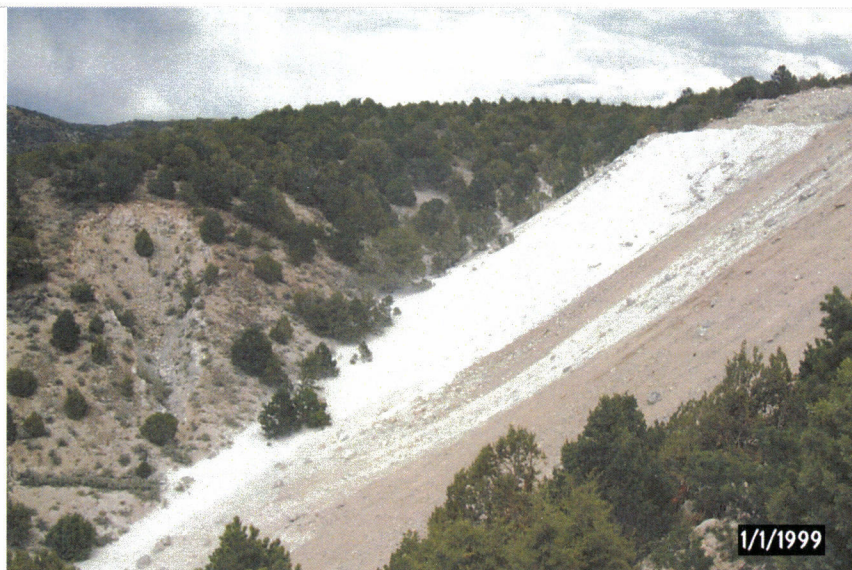
Fine perlite has been transported approximately 1000 feet downstream (per 2013 aerial photographs), mostly prior to 2006 (based on aerial photographs), and is not associated with the current erosion. The material transported off-site appears to originate from the west side of the north dump, where more fines appear to have been placed. Currently, erosion on this part of the dump is minor. The Notice of Intent identifies perlite fines as non-deleterious. This area should be re-evaluated in the future.

North dump in 2002. The fines had eroded off the dump and down the drainage.

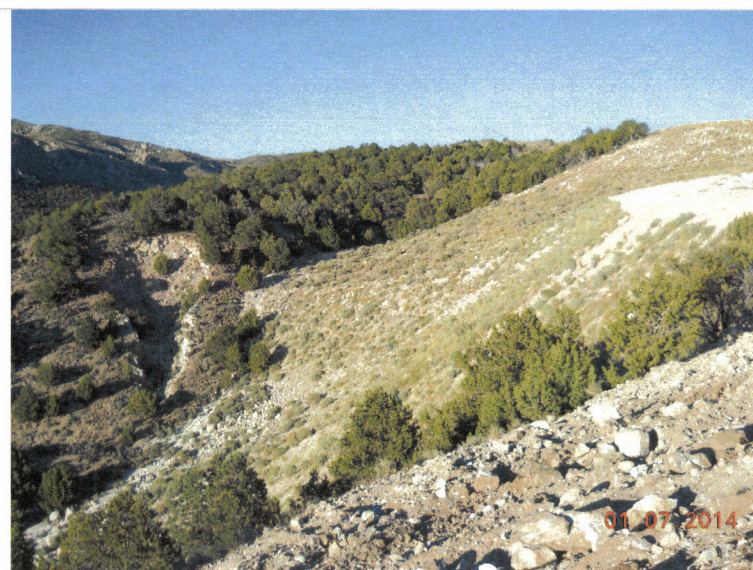
North dump in 2014. Revegetation is established in the west (perlite fines) area of the dump. The cut on the left appears to pre-date this permit, as juniper are growing.

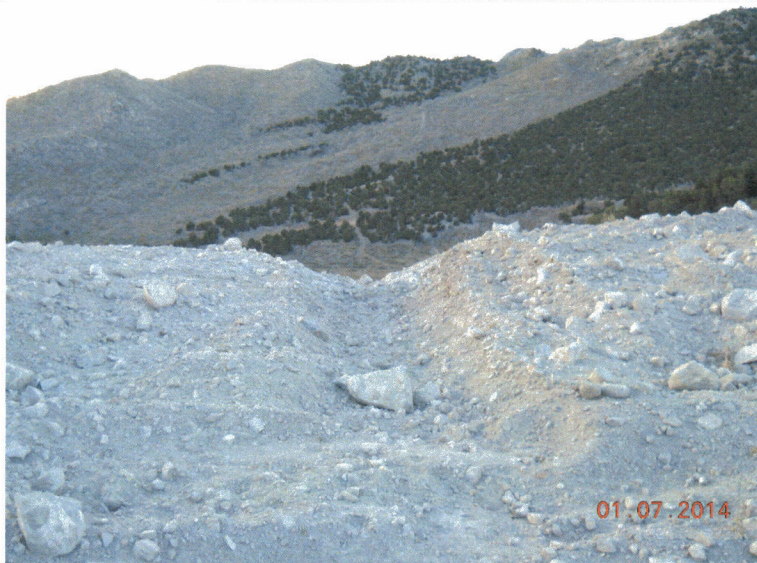
Revegetation was excellent overall, and earthwork reclamation on the regraded access road also looks very good. A partial release for revegetation and earthwork is recommended. During the 2014 road regrading, earthwork on the top of the north overburden dump has apparently enhanced rilling down the face of the angle-of-repose dump. Reclamation surety should be retained to cover the cost of revegetation on the recently regraded access road (<2 acres), as well as for reclamation of the north dump (~1.5 acres).

Channel cut across part of the north dump, which has concentrated flow over the rounded dump crest.

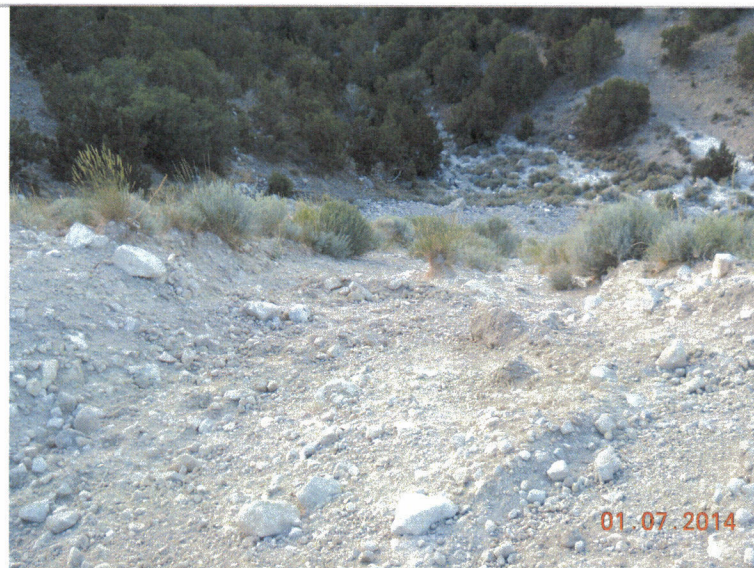
3.	Protection of Drainages/Erosion Control	<input checked="" type="checkbox"/>	<input type="checkbox"/>
Revegetated slopes are effectively controlling erosion in the areas of the pit. However, there is some active erosion on steep (angle-of-repose) dump slopes, where overburden, perlite waste, and fines were placed in the north drainage, despite significant revegetation. Aerial photos show some rilling down the face of the dump in 2013. Earlier in 2014, a channel was placed across part of the dump that concentrated runoff, and the crest of the dump was rounded slightly. The sediment retention capacity of large boulders placed at the toe of the dump in the natural drainage for erosion control is gone. Large storm events that generate runoff from the upstream mine site are not anticipated to occur frequently, but rilling will continue to develop and erosion will be ongoing without additional measures. Natural erosion is not insignificant in the area, especially after recent fires. Erosion should be evaluated periodically and prior to release of the remaining bond and permit closure.

The largest of a few flowpaths down the face of the north dump. This one is below the recently-cut channel. Note the depth of material eroded from around the grass in the middle.

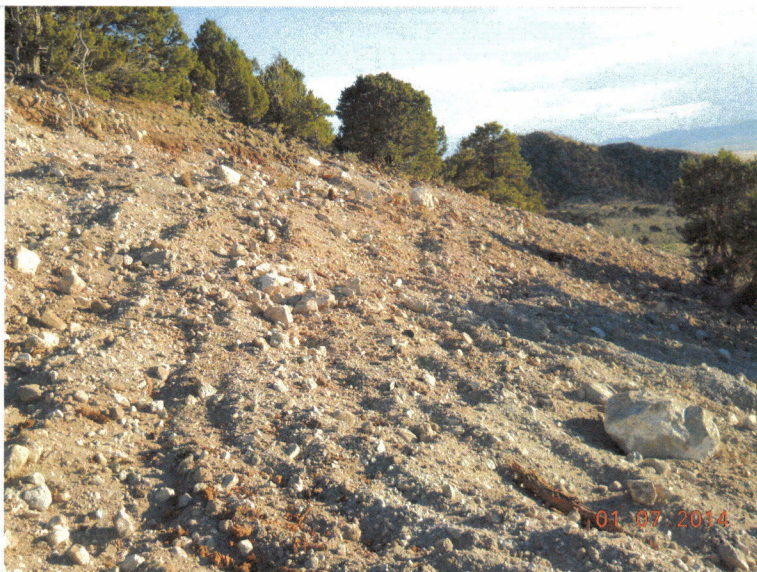
View down the reggraded access road.

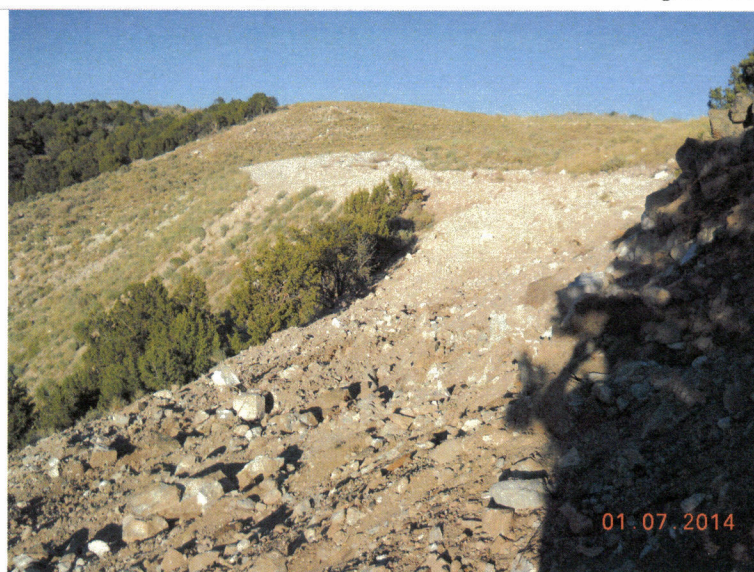
View up the reggraded access road, of the rounded north dump crest, and into the pit and north dump area.

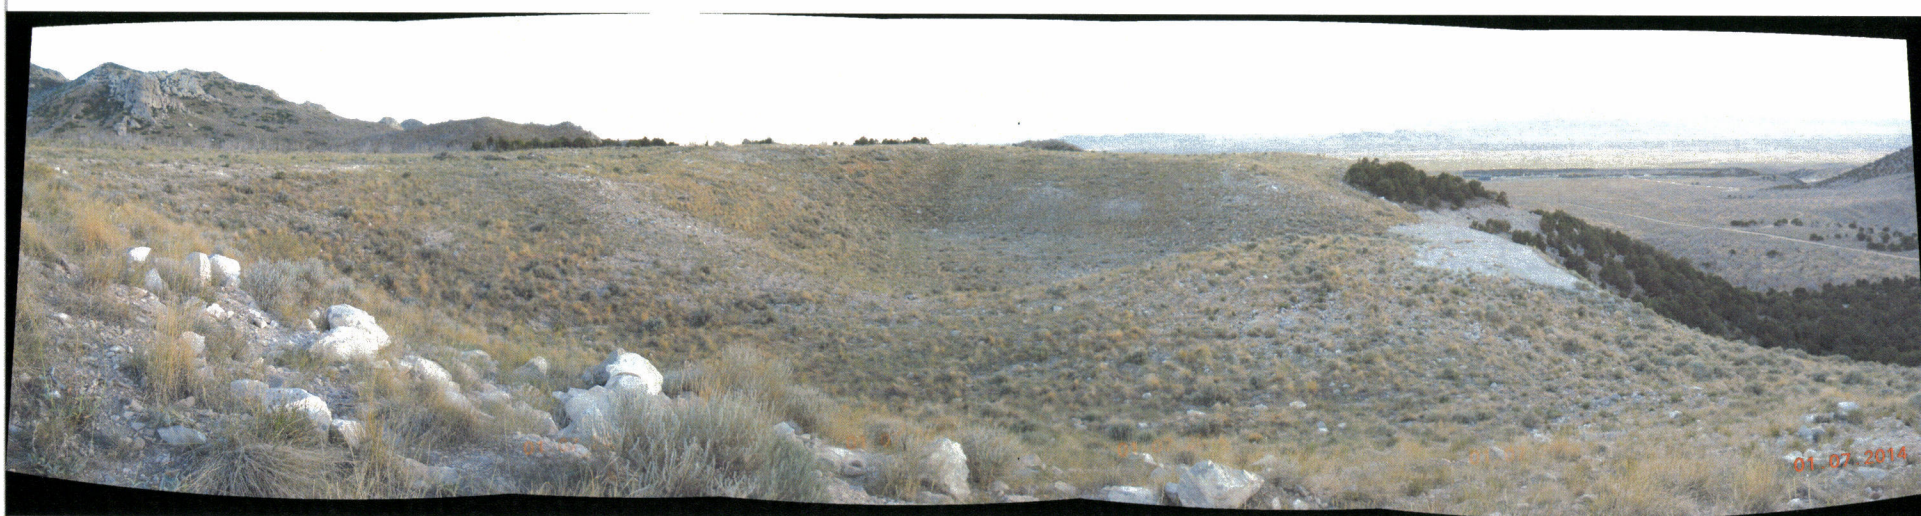
View of the regraded and revegetated Pearl Queen pit area, looking west. Note the recently regraded access road on the right. Revegetation requirements have been met for historical grading.

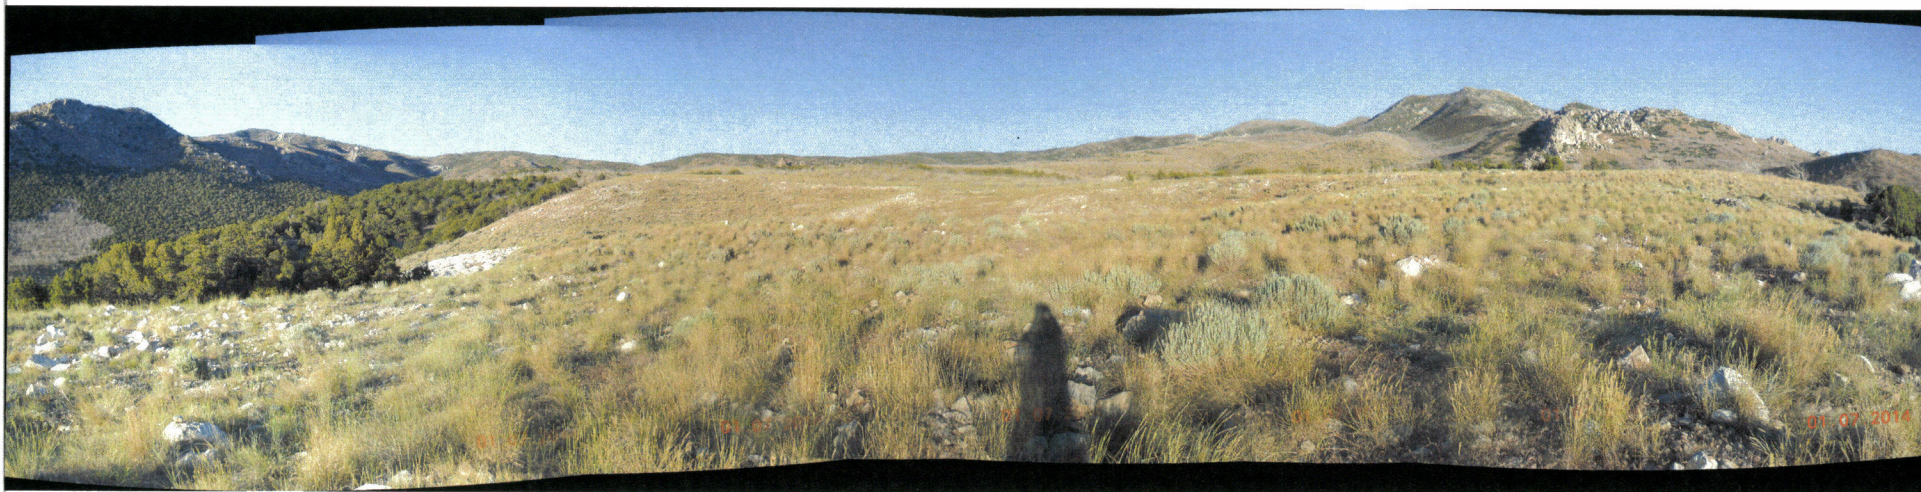
View of the regraded and revegetated Pearl Queen pit area, looking west.
